# Impact Testing on Reinforced Carbon-Carbon Flat Panels With Ice Projectiles for the Space Shuttle Return to Flight Program

*Matthew E. Melis, Duane M. Revilock, and Michael J. Pereira  
Glenn Research Center, Cleveland, Ohio*

*Karen H. Lyle  
Langley Research Center, Hampton, Virginia*

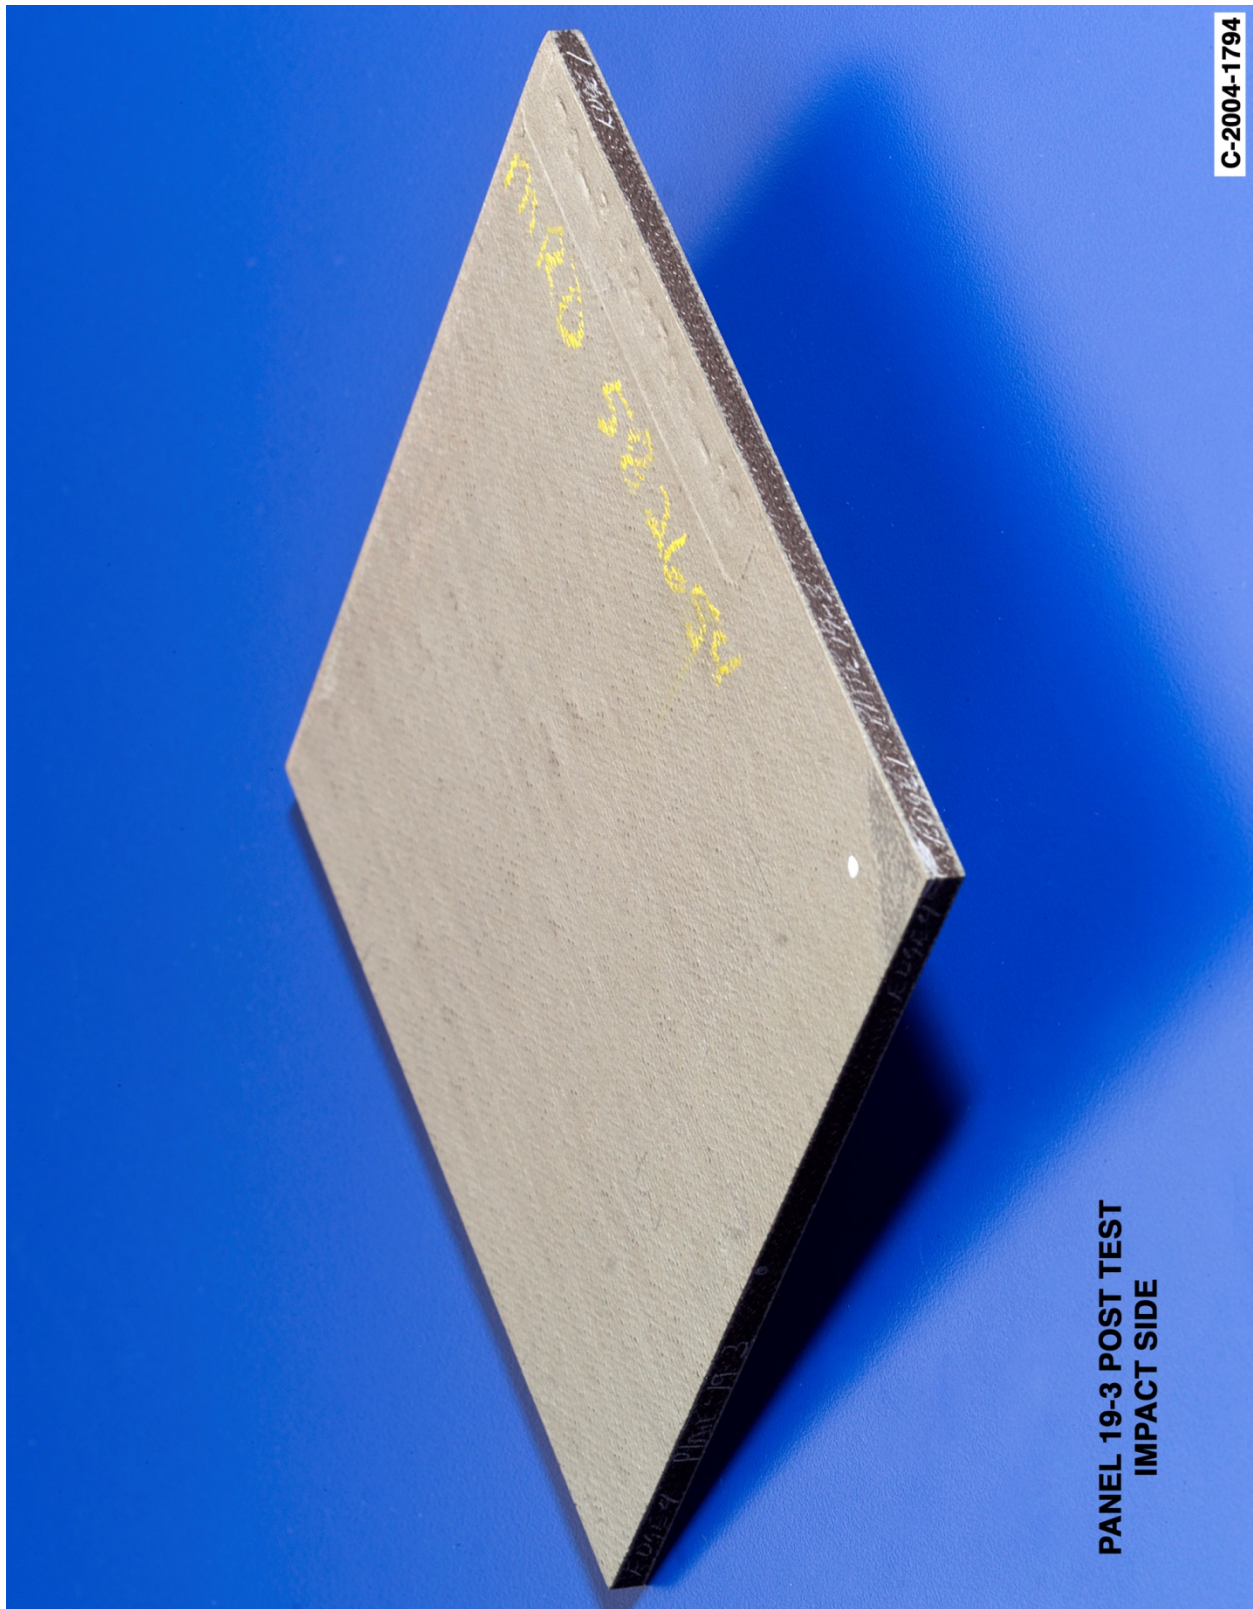
Figure B6-2.—Front (impact side) of panel 19-3 at 607 ft/s with a high-density, poly-crystal ice cylinder (nominally 0.66 in. in diameter by 1.66 in.) at 45° impact angle. Test GRCC 99.

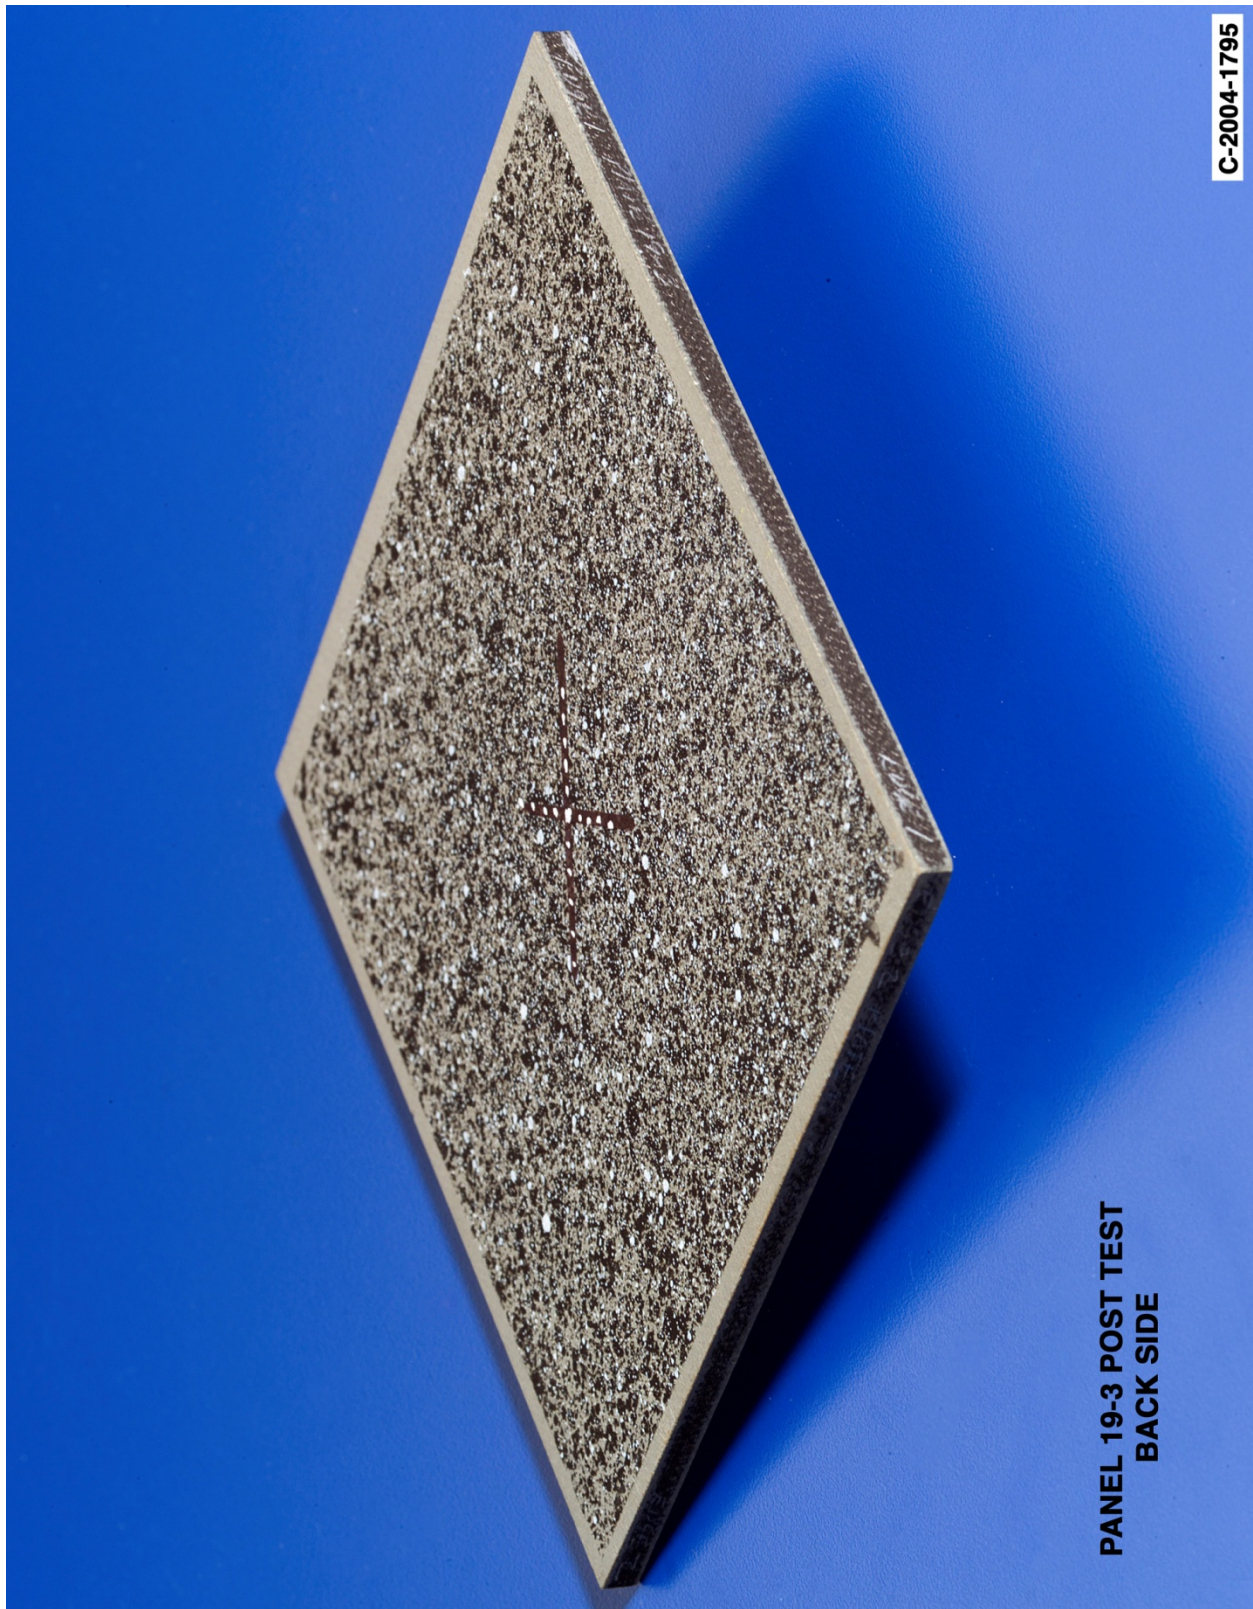
Figure B6-3.—Back face of panel 19-3 at 607 ft/s with a high-density, poly-crystal ice cylinder (nominally 0.66 in. in diameter by 1.66 in.) at 45° impact angle. Test GRCC 99.

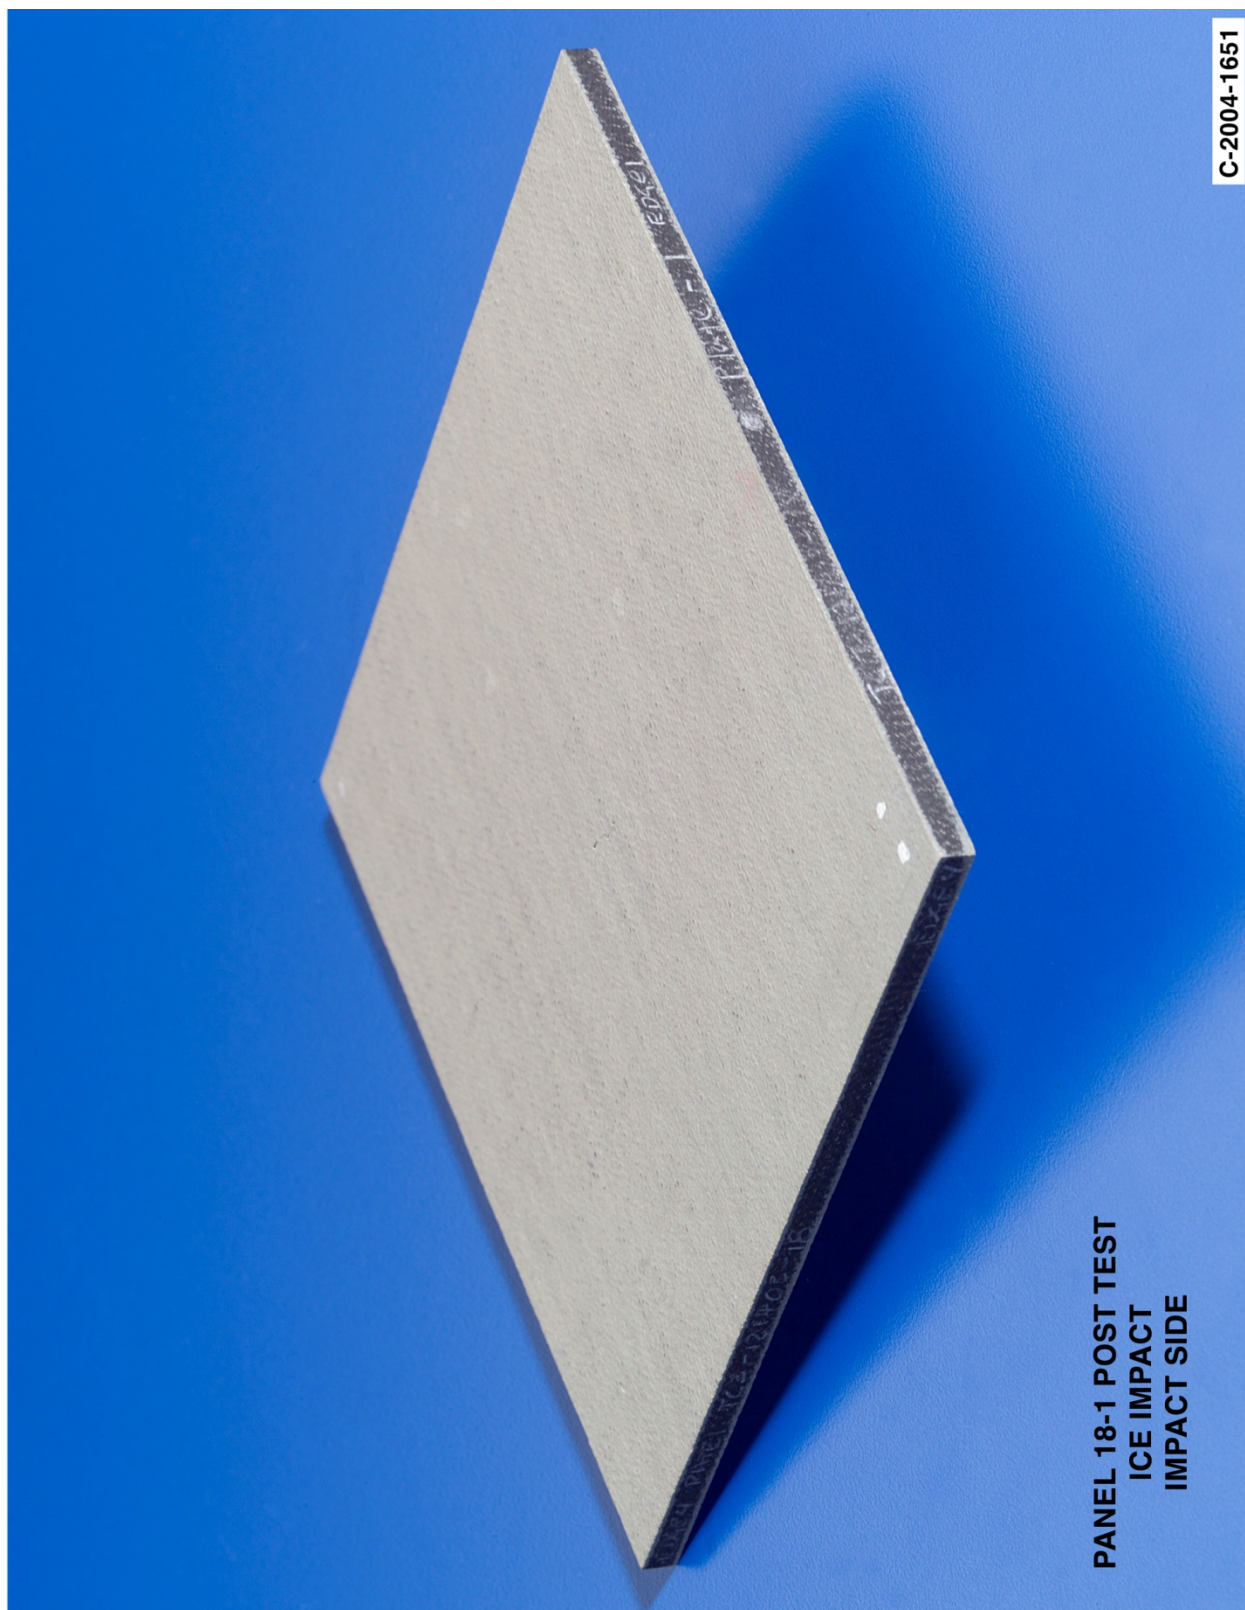
Figure B8–2.—Front (impact side) of panel 18-1 at 777 ft/s with a high-density, poly-crystal ice cylinder (nominally 0.66 in. in diameter by 1.66 in.) at 45° impact angle. Test GRCC 101.

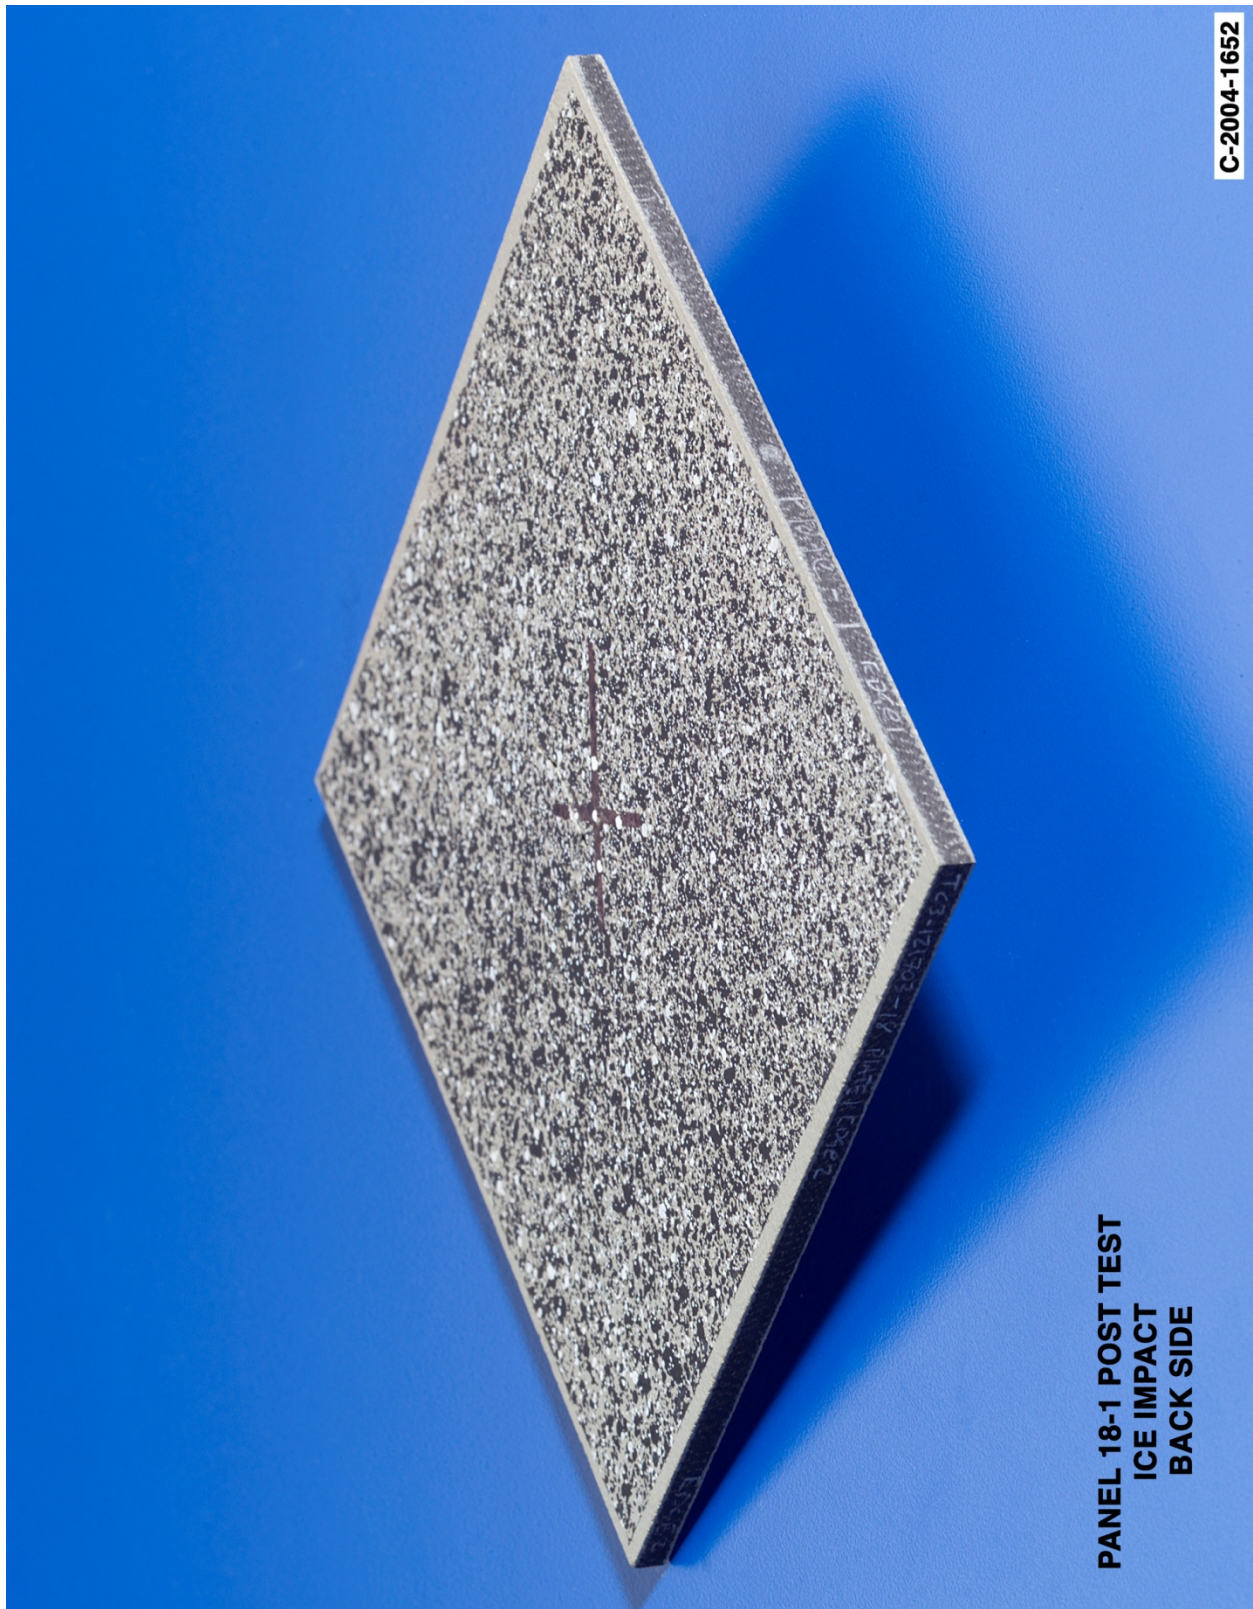
Figure B8-3.—Back face of panel 18-1 at 777 ft/s with a high-density, poly-crystal ice cylinder (nominally 0.66 in. in diameter by 1.66 in.) at 45° impact angle. Test GRCC 101.

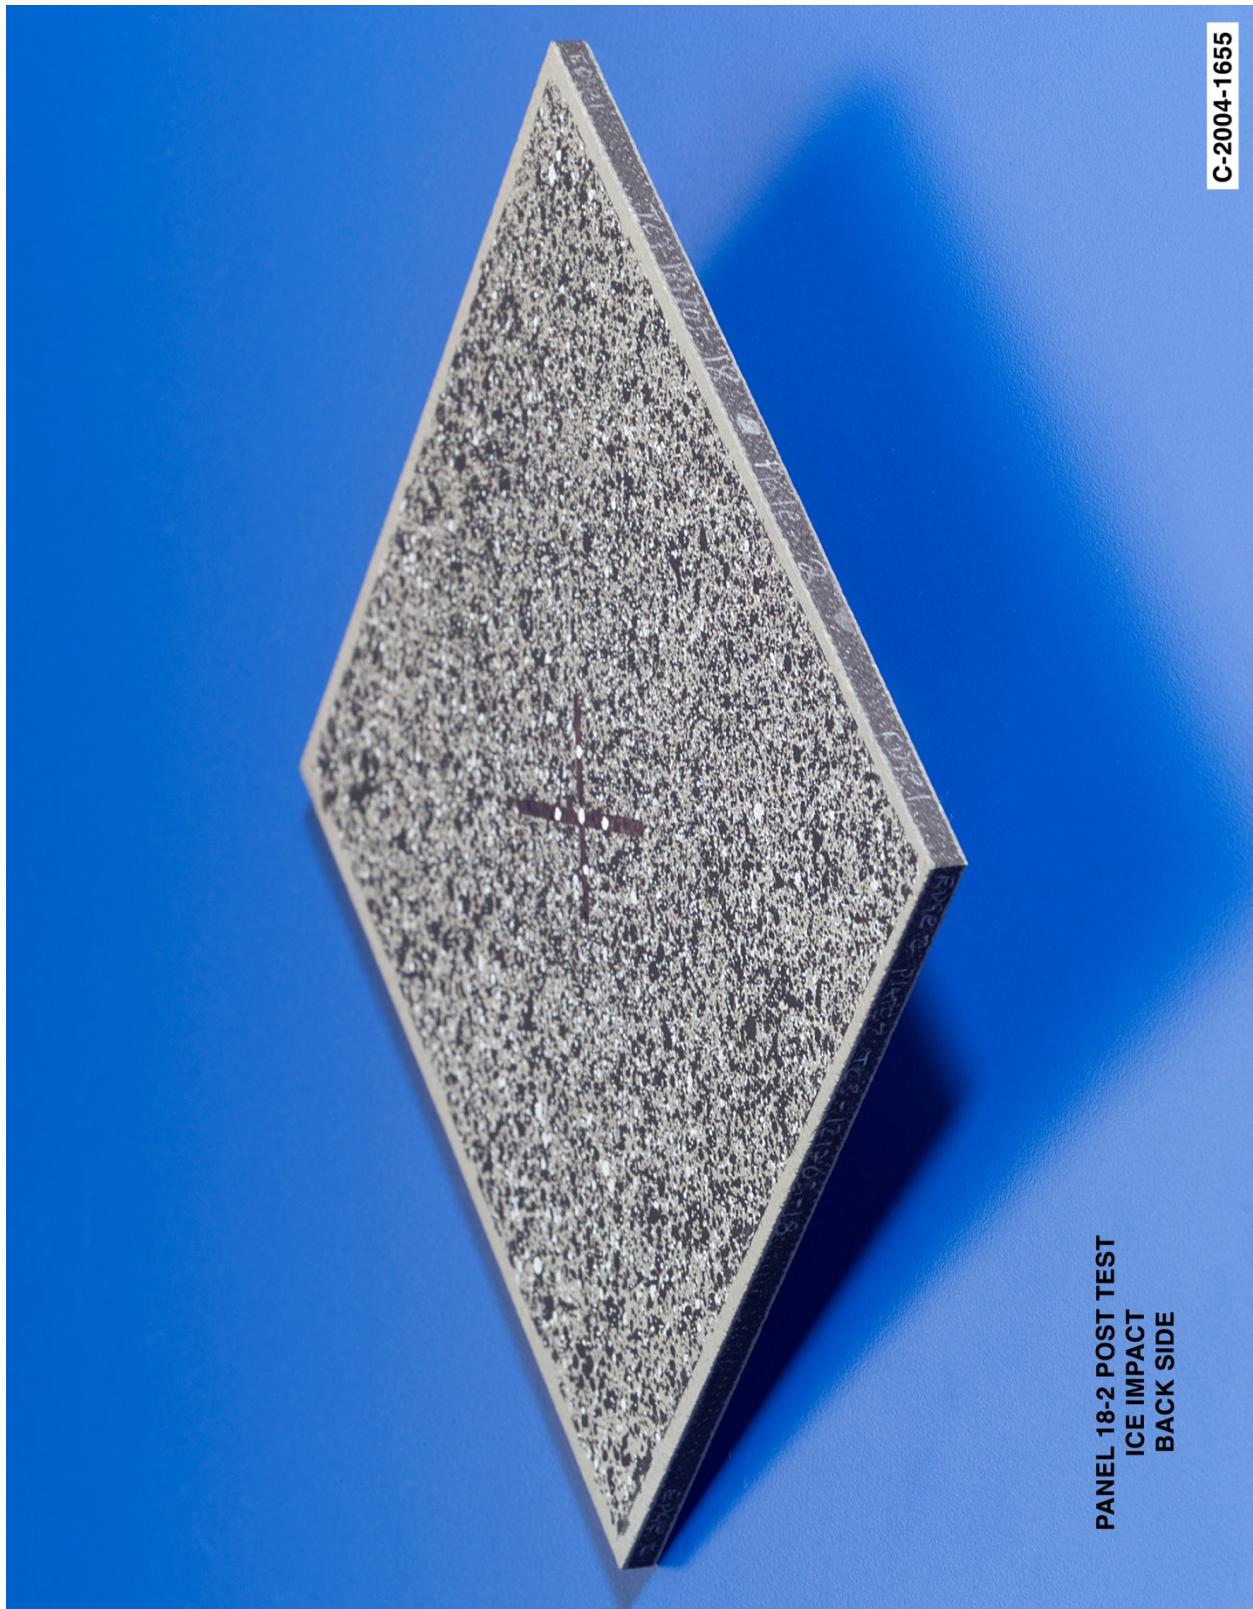
Figure B9-3.—Back face of panel 18-2 at 780 ft/s with a high-density, poly-crystal ice cylinder (nominally 0.66 in. in diameter by 1.66 in.) at 45° impact angle. Test GRCC 102.

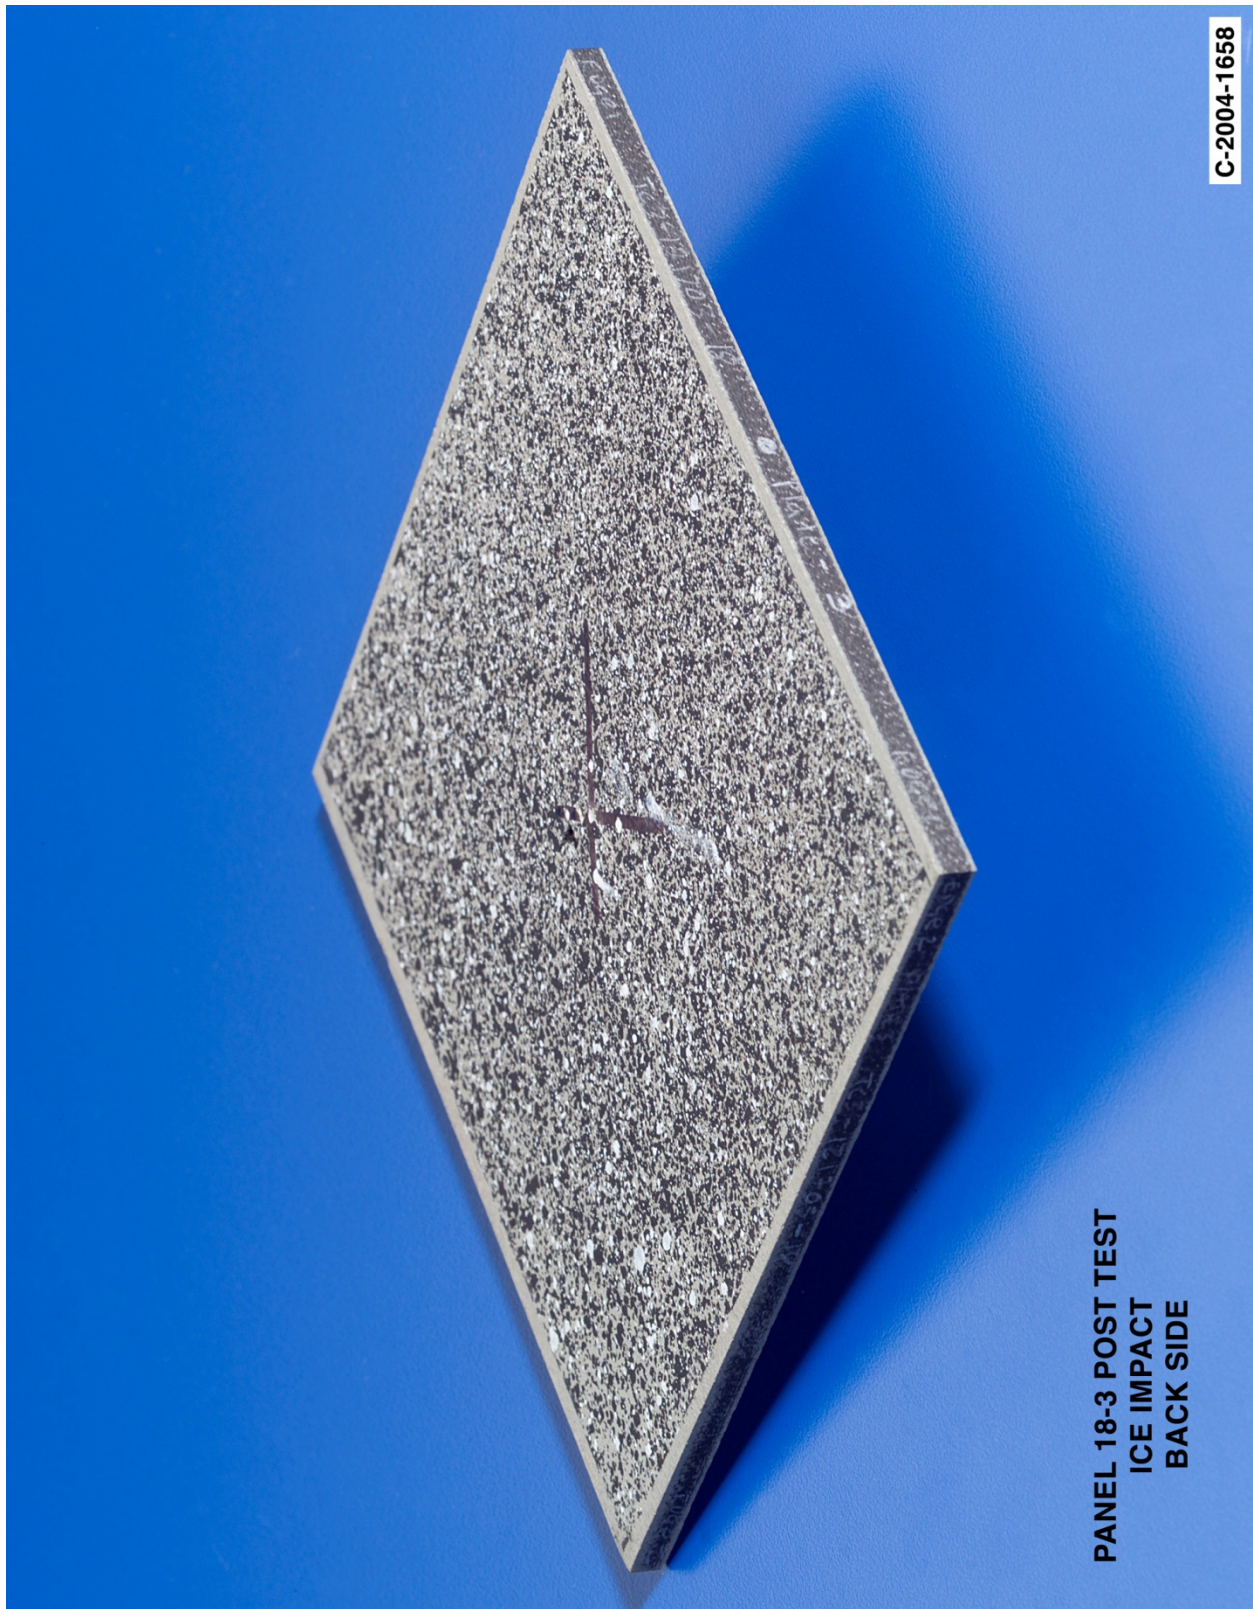
Figure B10-3.—Back face of panel 18-3 at 802 ft/s with a high-density, poly-crystal ice cylinder (nominally 0.66 in. in diameter by 1.66 in.) at 45° impact angle. Test GRCC 103.

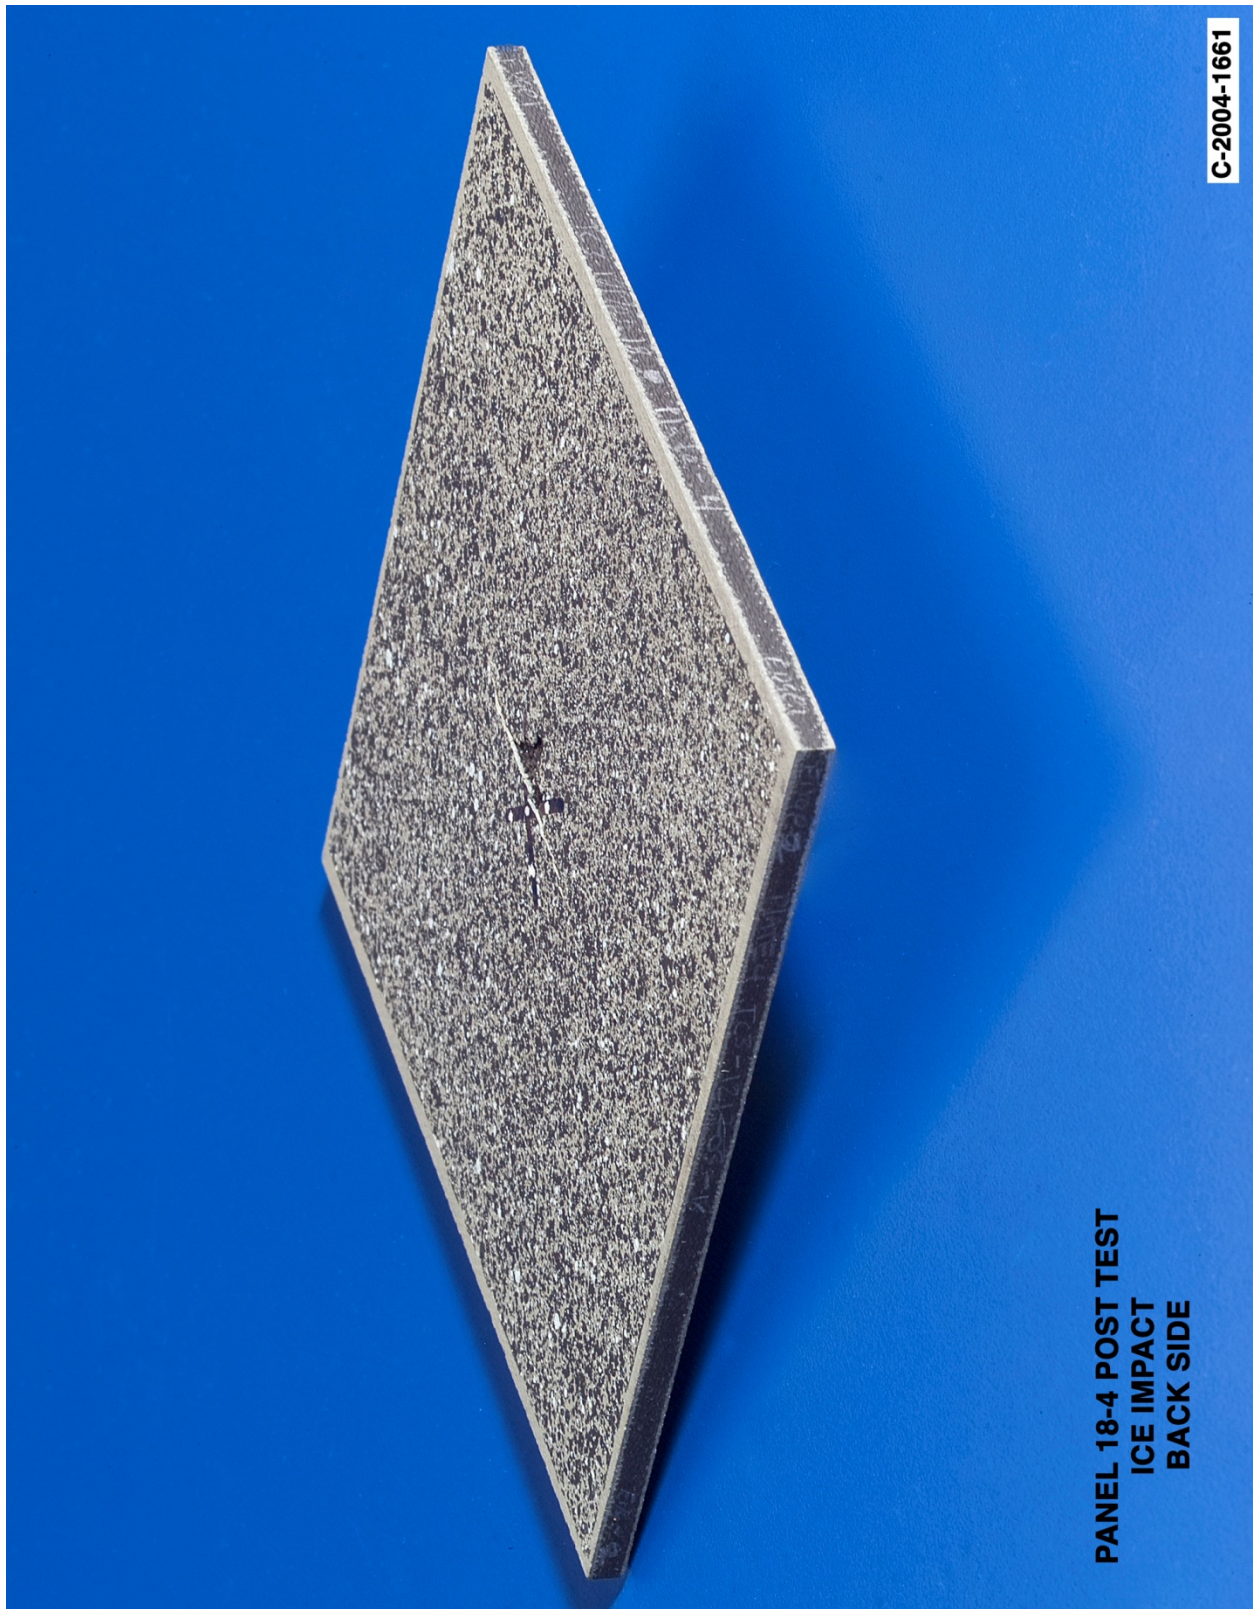
Figure B14-3.—Back face of panel 18-4 at 830 ft/s with a high-density, poly-crystal ice cylinder (nominally 0.66 in. in diameter by 1.66 in.) at 45° impact angle. Test GRCC 105.

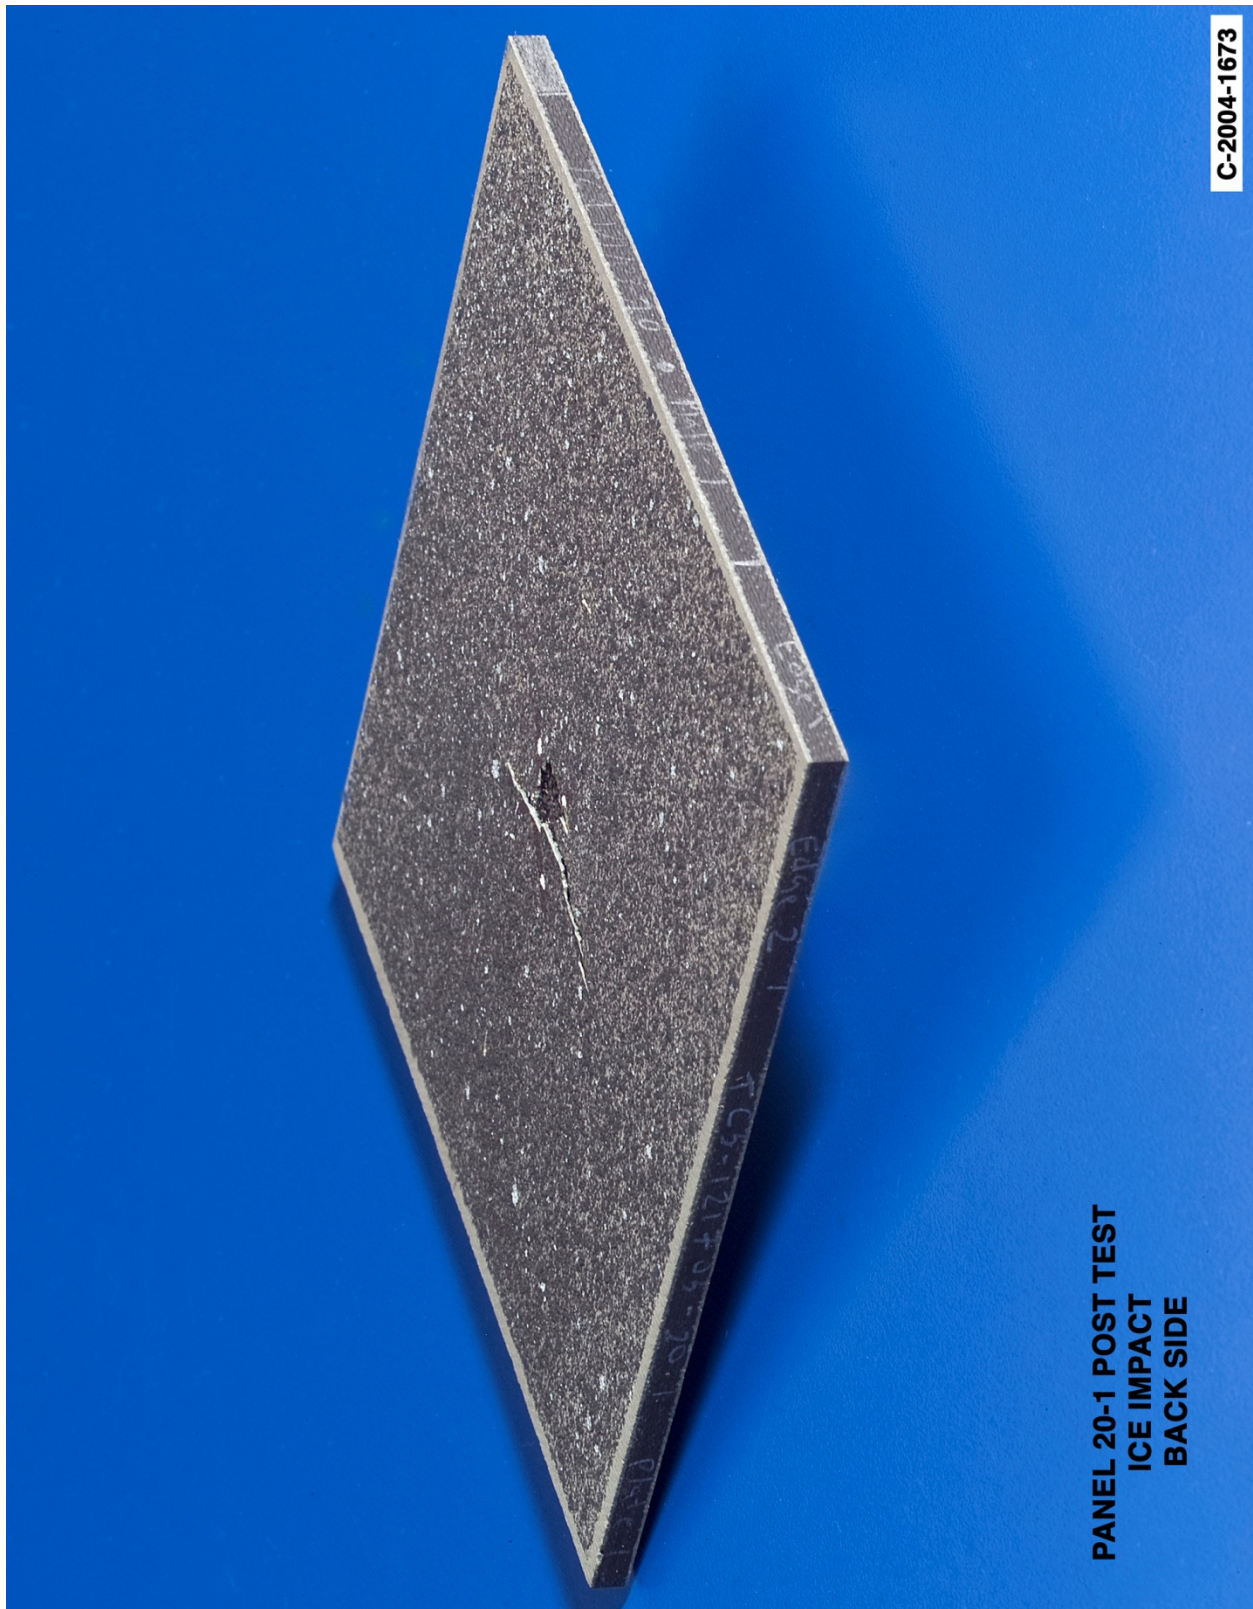
Figure B15-3.—Back face of panel 20-1 at 830 ft/s with a high-density, poly-crystal ice cylinder (nominally 0.66 in. in diameter by 1.66 in.) at 45° impact angle. Test GRCC 108.

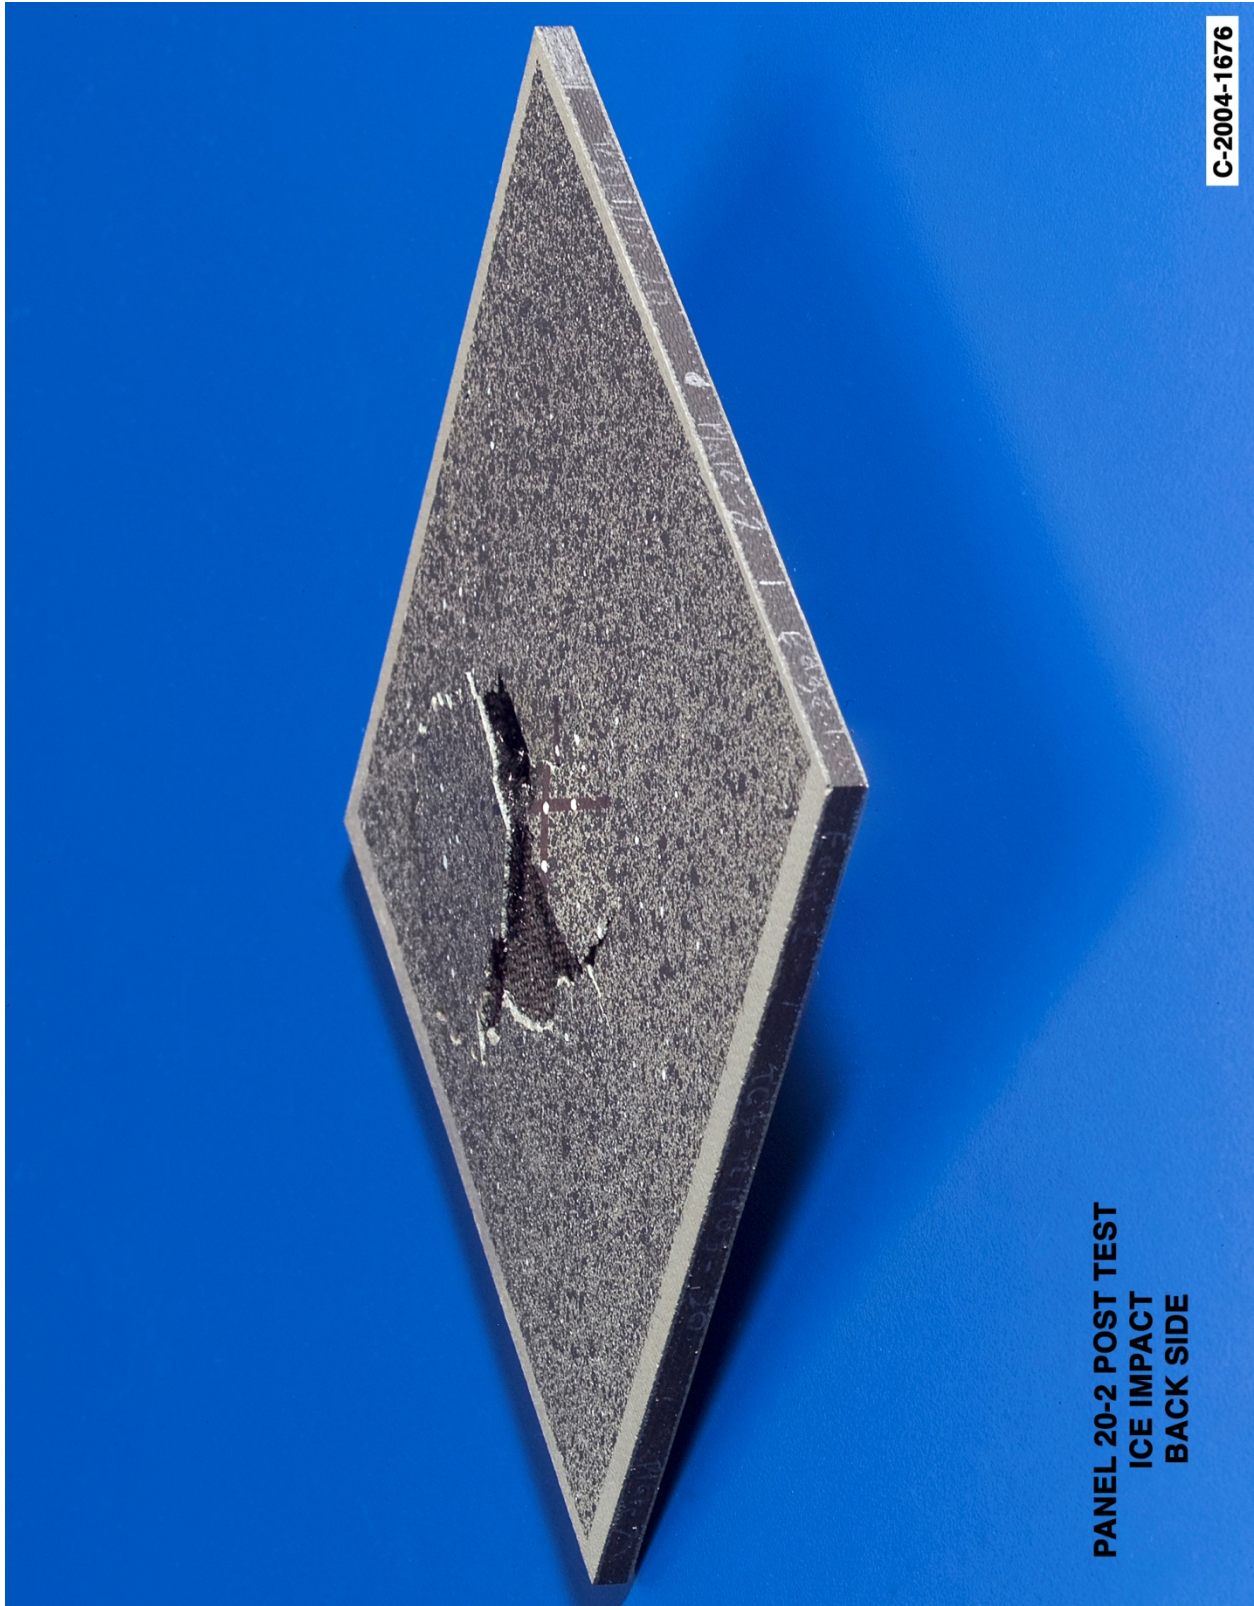
Figure B16–3.—Back face of panel 20-2 at 833 ft/s with a high-density, poly-crystal ice cylinder (nominally 0.66 in. in diameter by 1.66 in.) at 45° impact angle. Test GRCC 107.

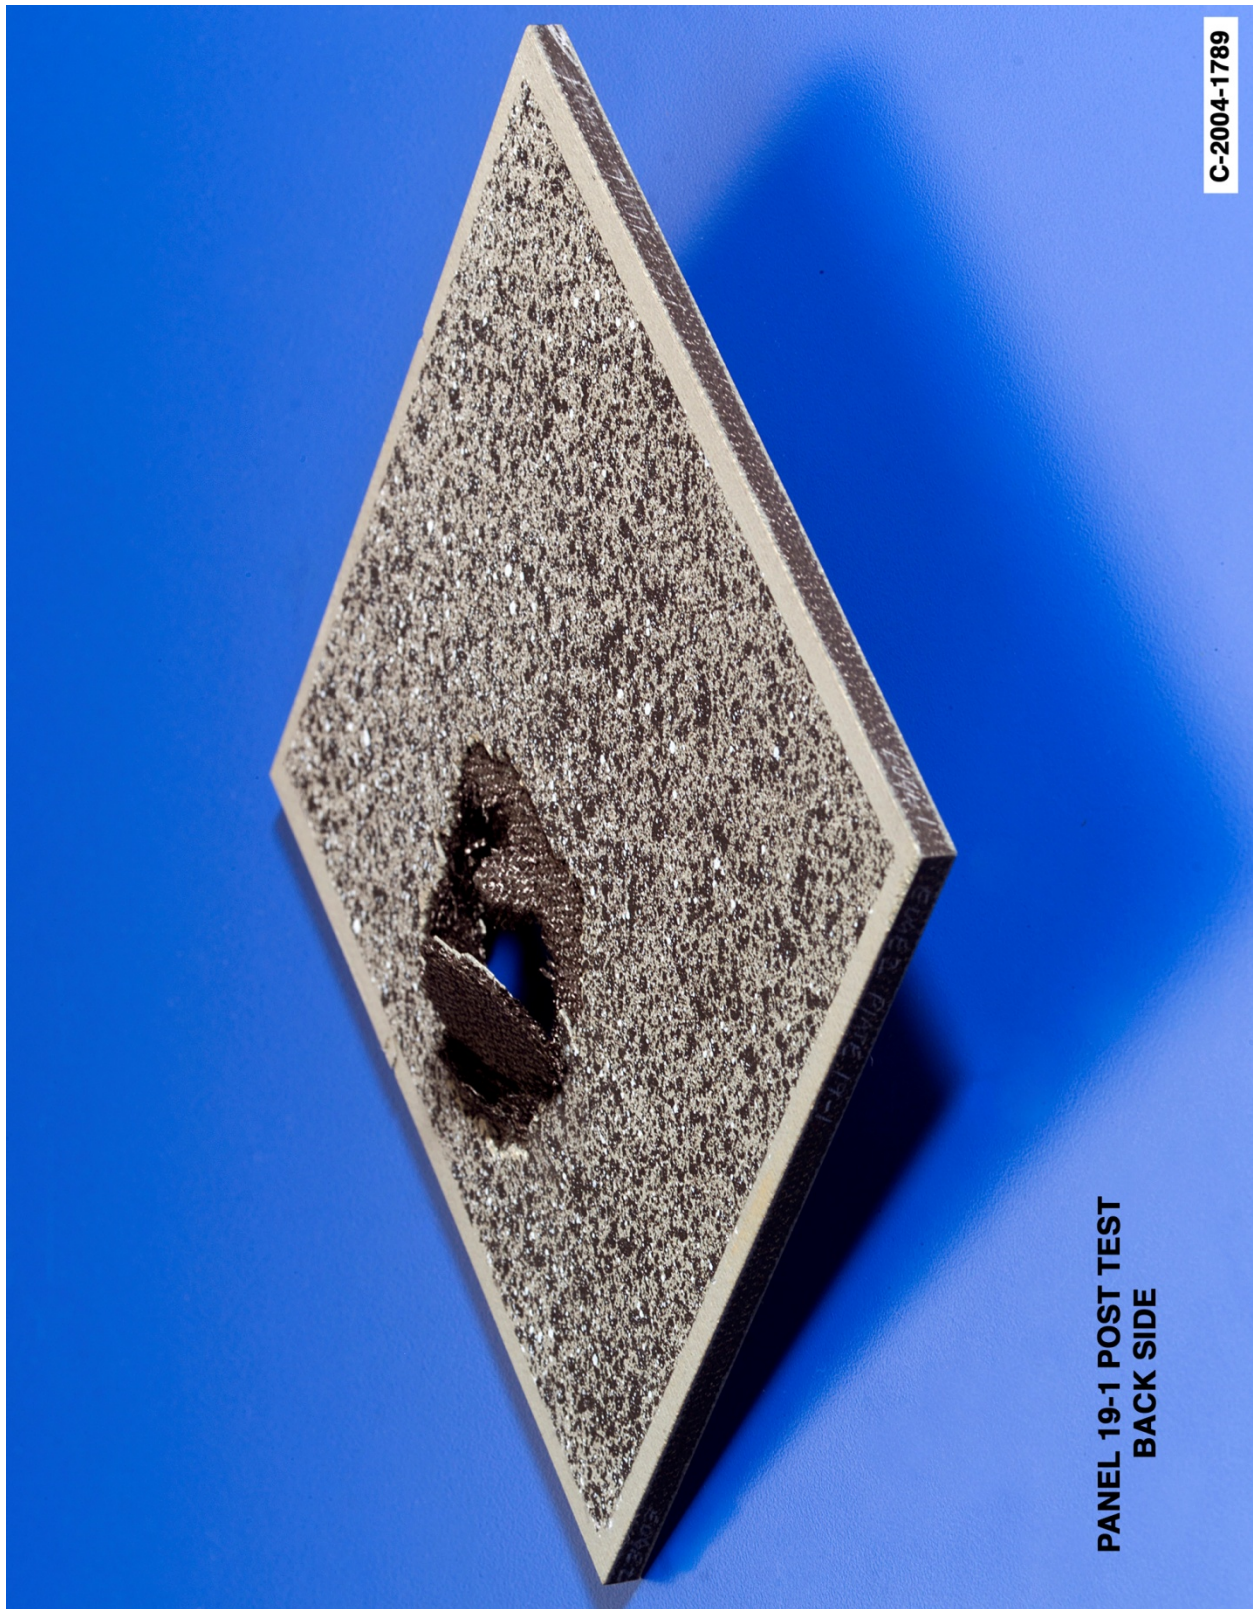
PANEL 19-1 POST TEST  
BACK SIDE

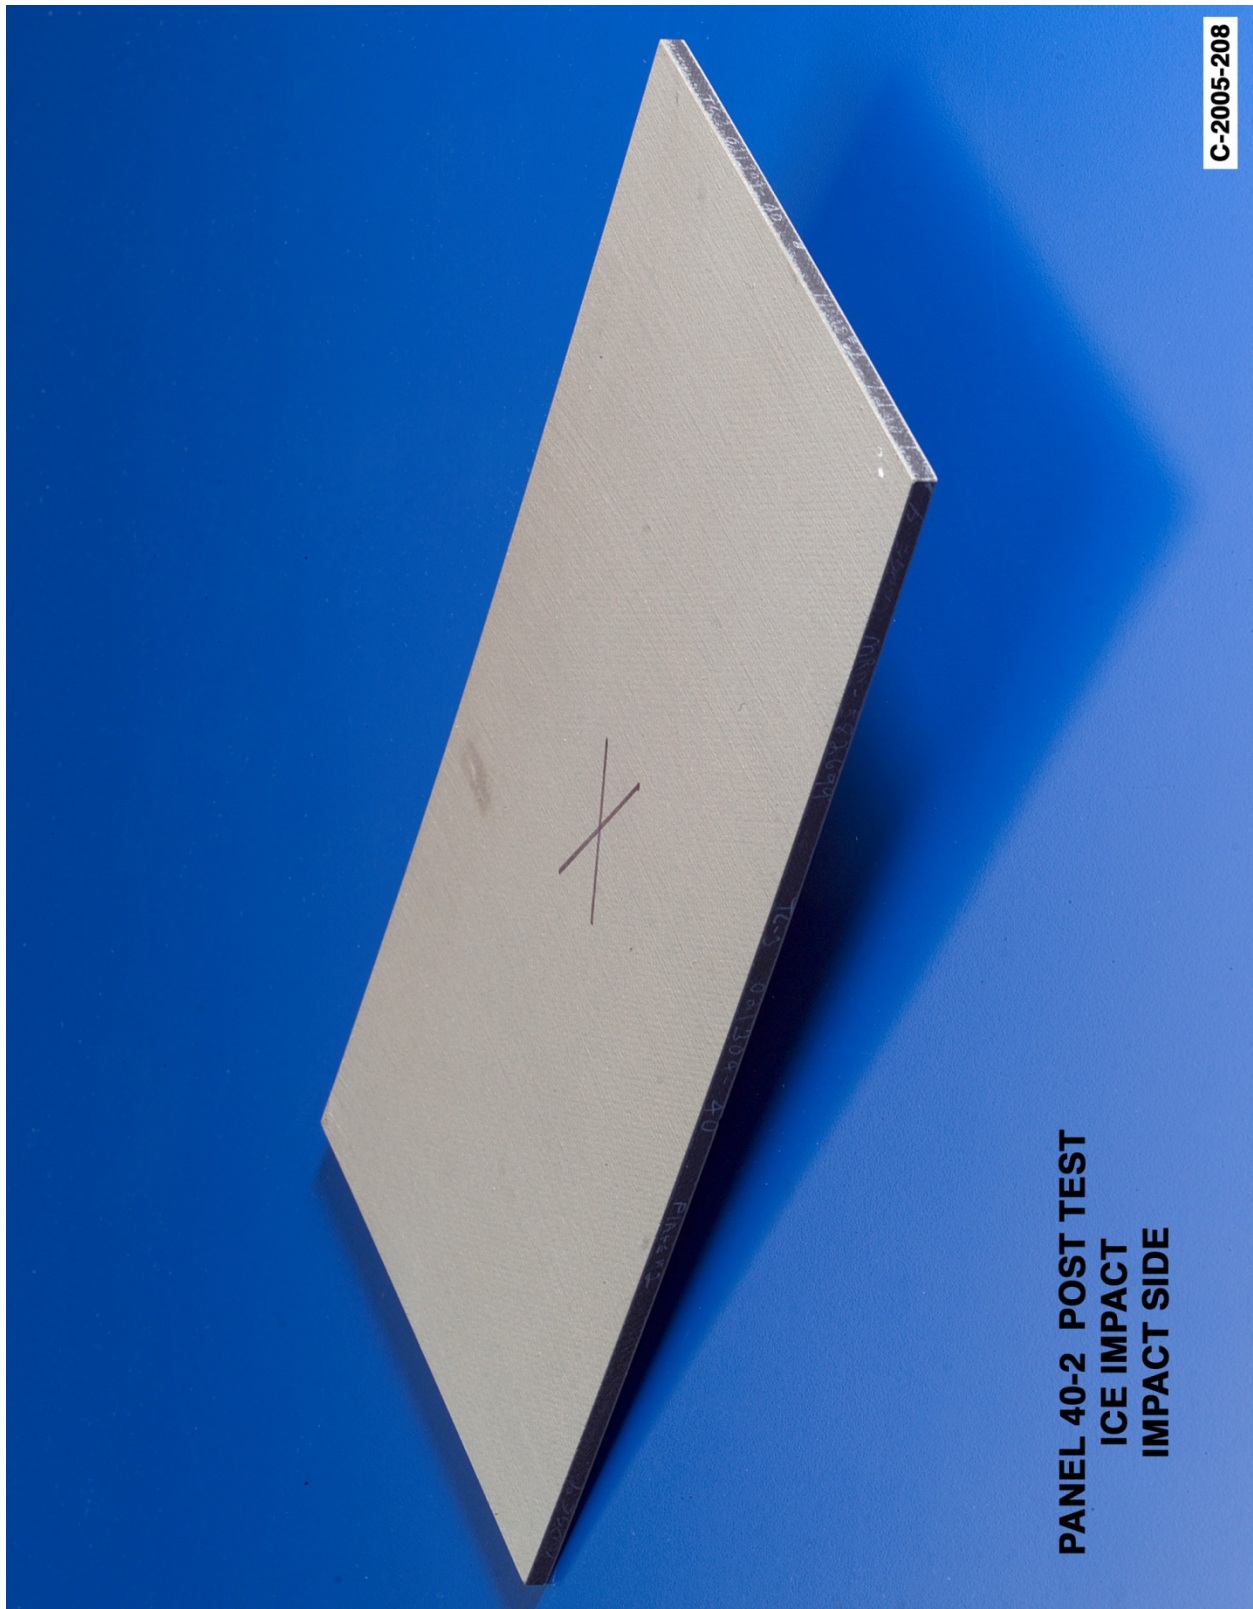
Figure C5-2.—Front (impact side) of panel 40-2 at 265 ft/s with a high-density, single-crystal ice cylinder (nominally 0.66 in. in diameter by 1.66 in.) at 90° impact angle. Test GRCC 159.

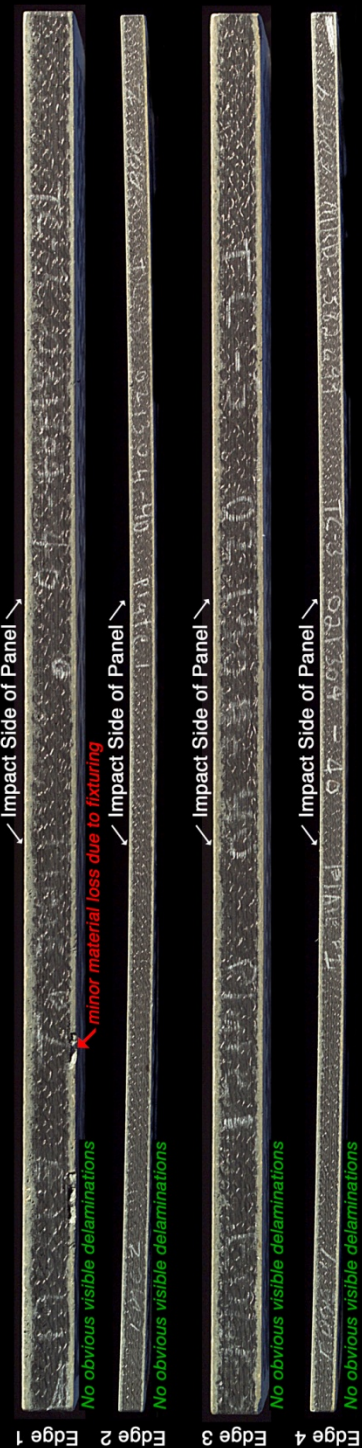
# Panel #40-1 Post Test Images - Poly Crystalline Ice Projectile 90 Degree Impact at 319 Feet Per Second

Back Side of Panel

Impact Side of Panel

Figure C6-1.—Edges and faces of panel 40-1 at 319 ft/s with a high-density, poly-crystal ice cylinder (nominally 0.66 in. in diameter by 1.66 in.) at 90° impact. Test GRCC 157.
